LANDOWNER STEWARDSHIP INFORMATION

NESTS TO DIE FOR – OPEN PIPES

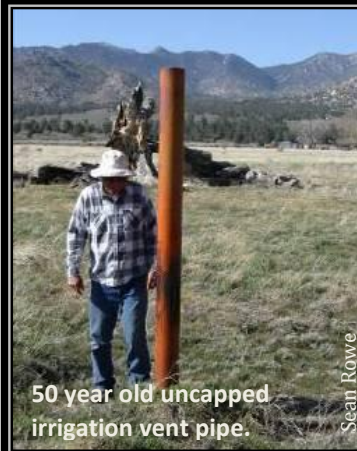
50 year old uncapped irrigation vent pipe.

Audubon California staff pulled down a 20-foot-tall ventilation pipe in 2009 from an abandoned irrigation system and discovered a seven-foot-long black mass composed entirely of decomposed carcasses of hundreds of dead birds and animals including kestrels, flickers, bluebirds, and fence lizards. The date etched into the concrete at the base of the pipe showed that it had been in place for more than 50 years.

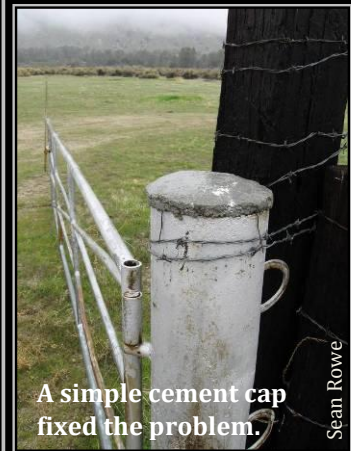
A simple cement cap fixed the problem.

- Look around and identify all the open top vertical pipes on your property.
- Cap, close, remove or screen all of them.
- Even pipes placed temporarily will trap birds.
- Put screens over sapling protector tubes, or leave openings at the bottom for birds and wildlife to escape.
- When you visit other properties – public or private – share what you know about the dangers of open pipes.

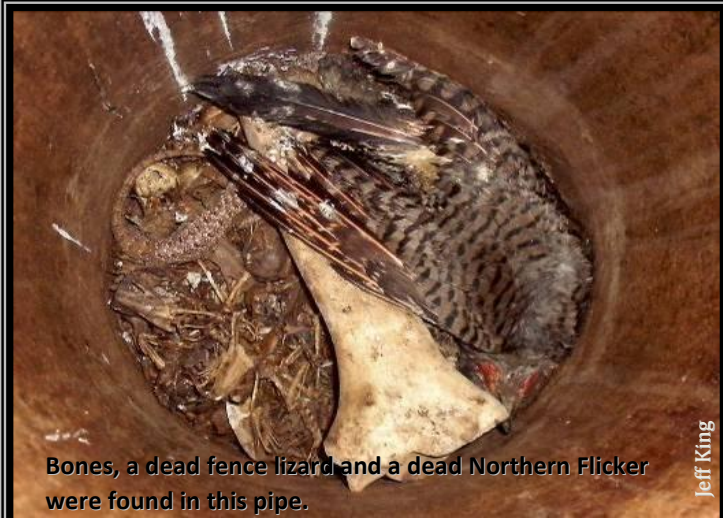
Bones, a dead fence lizard and a dead Northern Flicker were found in this pipe.

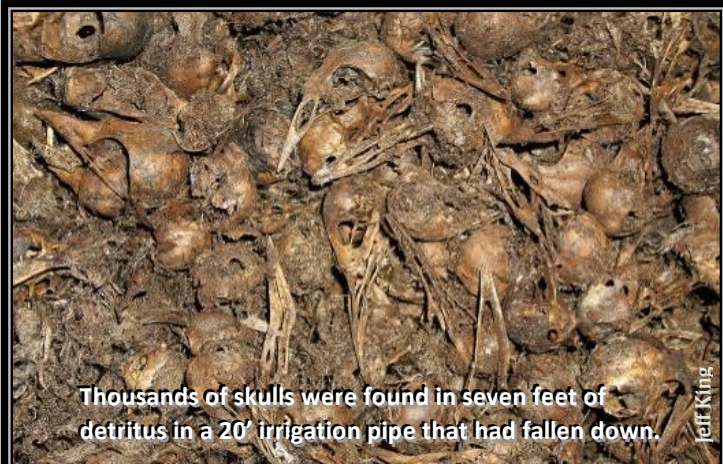
Thousands of skulls were found in seven feet of detritus in a 20' irrigation pipe that had fallen down.
